Femoral head wear and metallosis caused by damaged titanium porous coating after primary metal-on-polyethylene total hip arthroplasty: a case report

Croat Med J. 2018;59:253-7

<https://doi.org/10.3325/cmj.2018.59.253>

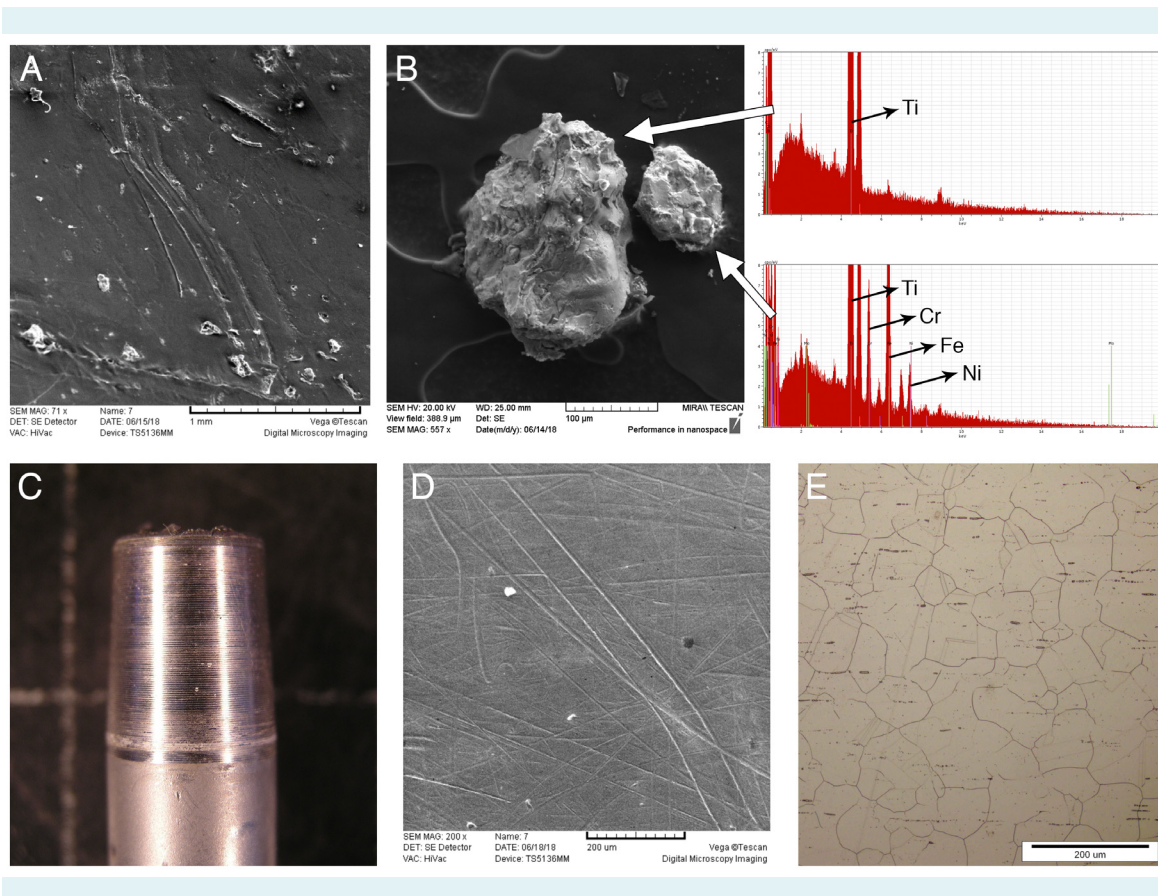
FIGURE 2. (A) Scanning electron microscopy image of the acetabular liner surface that was in contact with the worn femoral head, revealing damage, scratches, indentations, and embedded metal debris particles; (B) energy-dispersive spectroscopy image showing that the metal debris embedded in the acetabular liner contains both titanium and austenitic stainless-steel particles; (C) the femoral neck at the neck-head junction showing no signs of trunnionosis; (D) scanning electron microscopy image of the femoral head surface revealing scratches and damage typical for abrasive mechanical wear; (E) microstructure of the femoral head material typical for that kind of material: homogeneous austenitic without any significant defects or other irregularities. Abbreviations: Ti – titanium; Cr – chromium; Fe – iron; Ni – nickel.

Macro- and micro-structure of all extracted components were analyzed in detail at the Faculty of Mechanical Engineering and Naval Architecture of the University of Zagreb. The analysis revealed macroscopic damage to the titanium porous coating of the femoral stem (Figure 1F) and a decreased volume of the femoral head. Metal debris on the acetabular liner was distributed heterogeneously; fewer debris particles were present on the part of the liner adjoining the worn femoral head than on the remaining part of the liner. The surface damage features of the polyethylene were characterized by scanning electron microscopy (SEM) (TESCAN VEGA TS5136LS, TESCAN ORSAY HOLDING a.s., Brno-Kohoutovice, Czech Republic). SEM revealed damage, scratches, indentations, and embedded metal debris particles on the whole acetabular liner surface (Figure 2A). Chemical composition and origin of these particles were determined using energy-dispersive spectroscopy (EDS, OXFORD Instruments, Abingdon, UK), which showed that metal debris consisted of both titanium and stainless-steel particles (Figure 2B).

Femoral head component (AISI 316L stainless-steel) was removed from the femoral neck, and no signs of trunionosis were observed at the head/neck junction (Figure 2C). To determine the wear mechanisms, the wear tracks on the femoral head surface were analyzed by SEM, and only traces of abrasive wear were found (Figure 2D). The microstructure of the femoral head material was typical for this type of material: homogeneous austenitic without any significant defects or other irregularities (Figure 2E), with microhardness of 145 HV 0.2 (mean value of 5 measurements).

The main concern of this study was to determine the origin of the metal particles on the polyethylene surface and the type of femoral head wear. The SEM and EDS analysis showed the presence of titanium and austenitic stainless-steel particles (Figure 2B), suggesting that the origin of the titanium particles was the detached titanium porous coating of the femoral stem (Figure 1F). The SEM analysis of the femoral head confirmed that the wear was of the abrasive type and was probably caused by the titanium particles on the polyethylene surface because the hardness of stainless steel femoral head was lower than the titanium hardness described in the literature (145 compared to 200-362 HV 0.2) (6,7).
