# Femoral head wear and metallosis caused by damaged titanium porous coating after primary metal-on-polyethylene total hip arthroplasty: a case report

*Source / Izvornik:* **Croatian Medical Journal, 2018, 59, 253 - 257**

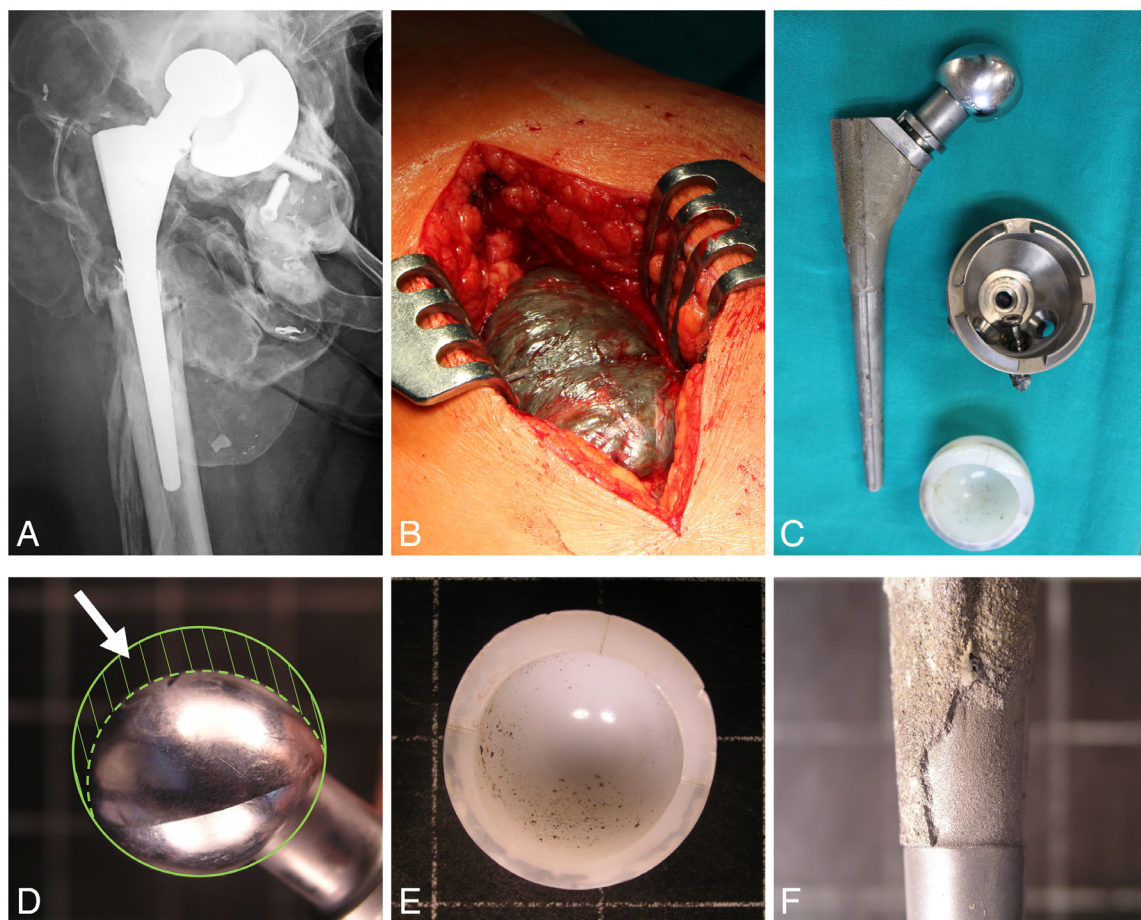
**FIGURE 1.** (A) Preoperative anteroposterior right hip x-ray showing acetabular cup dislocation, eccentric femoral head wear, “cloudy bubbles,” and pseudotumor formation; (B) intraoperative image after a direct lateral approach to the right hip showing extensive metallosis; (C) intraoperative image of the extracted endoprosthesis components; (D) eccentric wear of the femoral head (posterior view, arrowhead pointing approximately at the worn part of the femoral head); (E) metal debris particles embedded in the acetabular polyethylene – most of the particles are embedded in the part of the liner that was not in contact with the worn femoral head; (F) damaged titanium porous coating on the extracted femoral stem.

The initial x-ray examination in 2018 showed acetabular cup dislocation, eccentric femoral head wear, “cloudy bubbles” characteristic of metallosis, and pseudotumor formation (Figure 1A). It also showed damage to the titanium porous coating of the femoral stem. A review of the medical records from 2016 revealed femoral head wear *in situ* and damage to the porous stem coating. A revision surgery was indicated, and the patient agreed to the procedure.

During surgery, performed using direct lateral approach, extensive metallosis was observed (Figure 1B, [Supplemen-](#)

[tary Video 1](#)). After thorough debridement and irrigation, all implant components were removed (Figure 1C). The femoral head was gravely worn and elliptically shaped (Figure 1D). The polyethylene liner on the acetabular side had no visible holes or cracks, suggesting there was no direct contact between the femoral head and metal acetabular shell. After endoprosthesis extraction, notable polyethylene liner wear was visible, with metal debris covering the inner surface (Figure 1E). Due to a large acetabular bone defect, it was decided not to proceed with a new acetabular cup implantation. In the postoperative period, a coxofemoral orthosis was applied, and crutches were used for touchdown weight-bearing only. Intraoperatively collected microbiology culture swabs were negative for aerobic and anaerobic microorganisms.

Macro- and micro-structure of all extracted components were analyzed in detail at the Faculty of Mechanical Engineering and Naval Architecture of the University of Zagreb. The analysis revealed macroscopic damage to the titanium porous coating of the femoral stem (Figure 1F) and a decreased volume of the femoral head. Metal debris on the acetabular liner was distributed heterogeneously; fewer debris particles were present on the part of the liner adjoining the worn femoral head than on the remaining part of the liner. The surface damage features of the polyethylene were characterized by scanning electron microscopy (SEM) (TESCAN VEGA TS5136LS, TESCAN ORSAY HOLDING a.s., Brno-Kohoutovice, Czech Republic). SEM revealed damage, scratches, indentations, and embedded metal debris particles on the whole acetabular liner surface (Figure 2A). Chemical composition and origin of these particles were determined using energy-dispersive spectroscopy (EDS, OXFORD Instruments, Abingdon, UK), which showed that metal debris consisted of both titanium and stainless-steel particles (Figure 2B).

Our study showed that detached titanium porous coating of the femoral stem can cause the stainless-steel femoral head wear in primary metal-on-polyethylene THA. As soon as such detachment becomes evident on routine follow-up radiographs, revision surgery should be considered to prevent devastating complications described in this report.

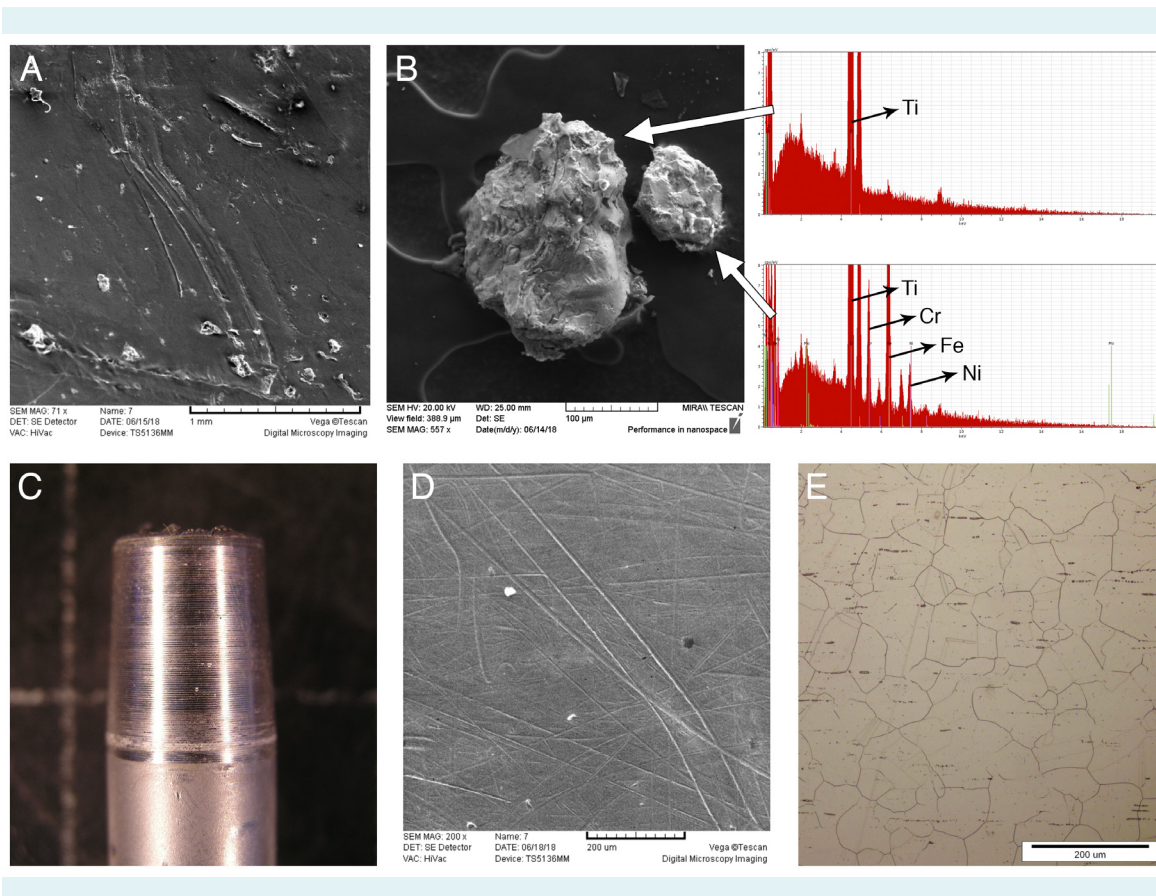
**FIGURE 2.** (A) Scanning electron microscopy image of the acetabular liner surface that was in contact with the worn femoral head, revealing damage, scratches, indentations, and embedded metal debris particles; (B) energy-dispersive spectroscopy image showing that the metal debris embedded in the acetabular liner contains both titanium and austenitic stainless-steel particles; (C) the femoral neck at the neck-head junction showing no signs of trunnionosis; (D) scanning electron microscopy image of the femoral head surface revealing scratches and damage typical for abrasive mechanical wear; (E) microstructure of the femoral head material typical for that kind of material: homogeneous austenitic without any significant defects or other irregularities. Abbreviations: Ti – titanium; Cr – chromium; Fe – iron; Ni – nickel.

Femoral head component (AISI 316L stainless-steel) was removed from the femoral neck, and no signs of trunionosis were observed at the head/neck junction (Figure 2C). To determine the wear mechanisms, the wear tracks on the femoral head surface were analyzed by SEM, and only traces of abrasive wear were found (Figure 2D). The microstructure of the femoral head material was typical for this type of material: homogeneous austenitic without any significant defects or other irregularities (Figure 2E), with microhardness of 145 HV 0.2 (mean value of 5 measurements).

The main concern of this study was to determine the origin of the metal particles on the polyethylene surface and the type of femoral head wear. The SEM and EDS analysis showed the presence of titanium and austenitic stainless-steel particles (Figure 2B), suggesting that the origin of the titanium particles was the detached titanium porous coating of the femoral stem (Figure 1F). The SEM analysis of the femoral head confirmed that the wear was of the abrasive type and was probably caused by the titanium particles on the polyethylene surface because the hardness of stainless steel femoral head was lower than the titanium hardness described in the literature (145 compared to 200-362 HV 0.2) (6,7).
