Complications of Percutaneous Vertebroplasty: A Pictorial Review

Abstract: Percutaneous vertebroplasty is a minimally invasive treatment technique for vertebral body compression fractures. The complications associated with this technique can be categorized into mild, moderate, and severe. Among these, the most prevalent complication is cement leakage, which may insert into the epidural, intradiscal, foraminal, and paravertebral regions, and even the venous system. The occurrence of a postprocedural infection carries a notable risk which is inherent to any percutaneous procedure. While the majority of these complications manifest without symptoms, they can potentially lead to severe outcomes. This review aims to consolidate the various complications linked to vertebroplasty, drawing from the experiences of a single medical center.

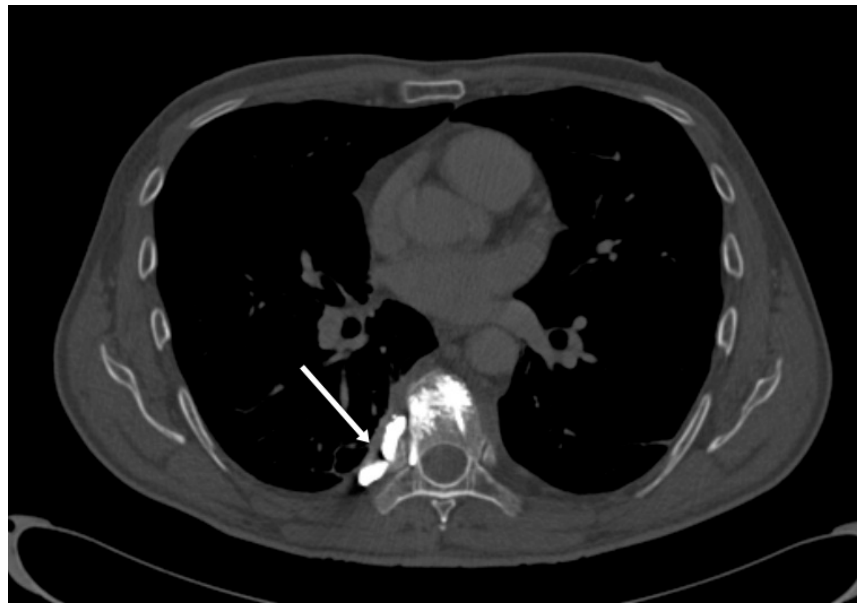
Figure 3. Cement leakage into the right subpleural space following vertebroplasty of Th8 vertebra (arrow).

Leakage was more frequently observed within the perivertebral venous plexus in comparison to the nearby intervertebral discs or the surrounding soft tissues (see Figure 3). The venous network traversing the vertebral column consists of three primary interconnected systems: the internal venous plexus, the external venous plexus, and the basivertebral system. Originating within the anterior one-third of the vertebral body, the basivertebral veins converge towards the posterior region, where they drain into the anterior part of the internal venous plexus. In the anterior area, these basivertebral veins merge with the external plexus. Positioned on the dorsal surface of the vertebral body, the exit point of the basivertebral vein lies centrally between the pedicles. The anterior component of the internal venous plexus empties into the segmental veins, which exit the spinal canal through the foramen located between the nerve root and the medial aspect of the pedicles. This implies a direct venous link connecting the bone marrow with the foraminal space [20].
