Complications of Percutaneous Vertebroplasty: A Pictorial Review

Review **Complications of Percutaneous Vertebroplasty: A Pictorial Review**

Keywords: vertebroplasty; complication; cement leakage; spondylodiscitis

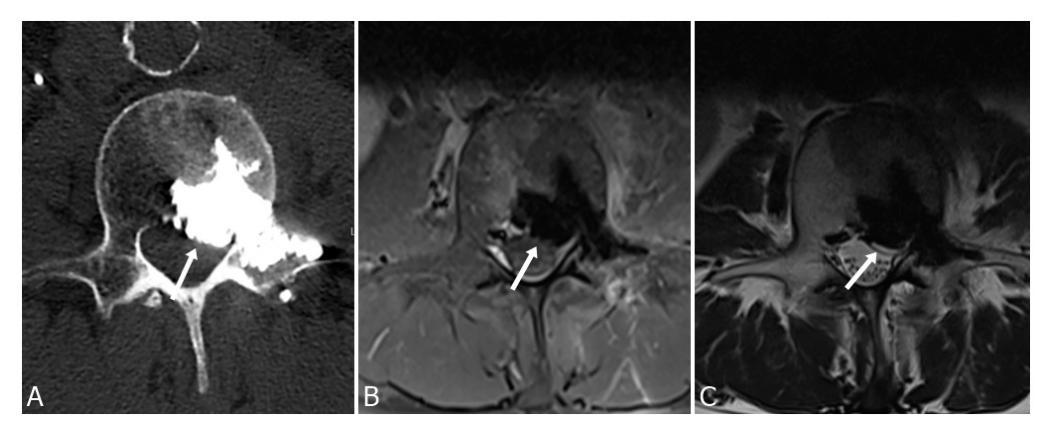
Figure 1. Cement leakage into epidural space with compression of the dural sac (arrows) seen on axial CT image (**A**), T1-weighted (**B**), and T2-weighted (**C**) MRI images, following vertebroplasty of L2 vertebrae in a 67-year-old man.

Cement leakage into the foraminal or epidural spaces may lead to compromised neurological status due to spinal cord or nerve root damage, which is dependent on the volume of the leakage (Figure 1). Most cases remain clinically asymptomatic or with negligible symptoms [2].

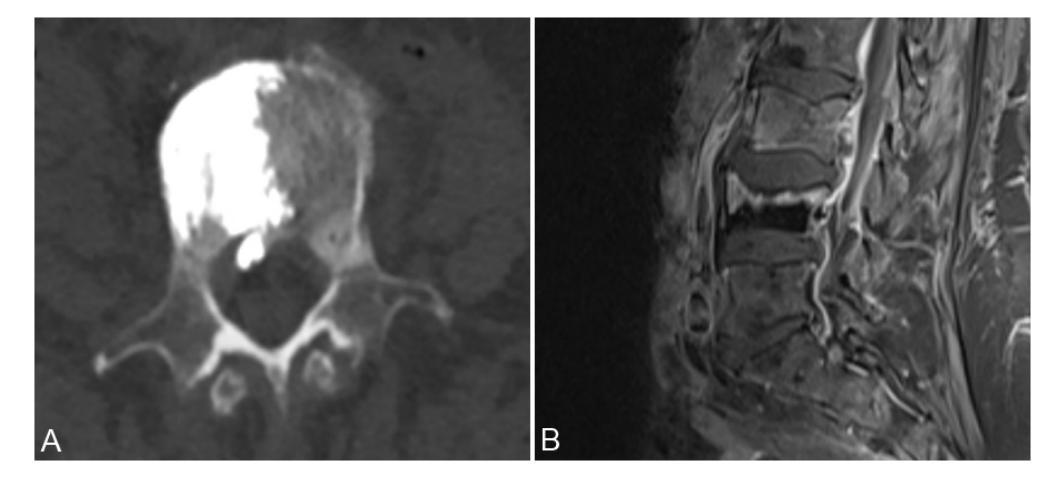
Figure 2. Axial CT image (**A**) and T2 weighted sagittal MRI image (**B**) show discrete intraspinal bone cement leakage.

Type S leaks usually follow a horizontal trajectory, tracing alongside the segmental veins. On the other hand, type C leakage emerges from a cortical disruption encircling a vertebral body, potentially extending into the spinal canal (refer to Figure 2) [19].

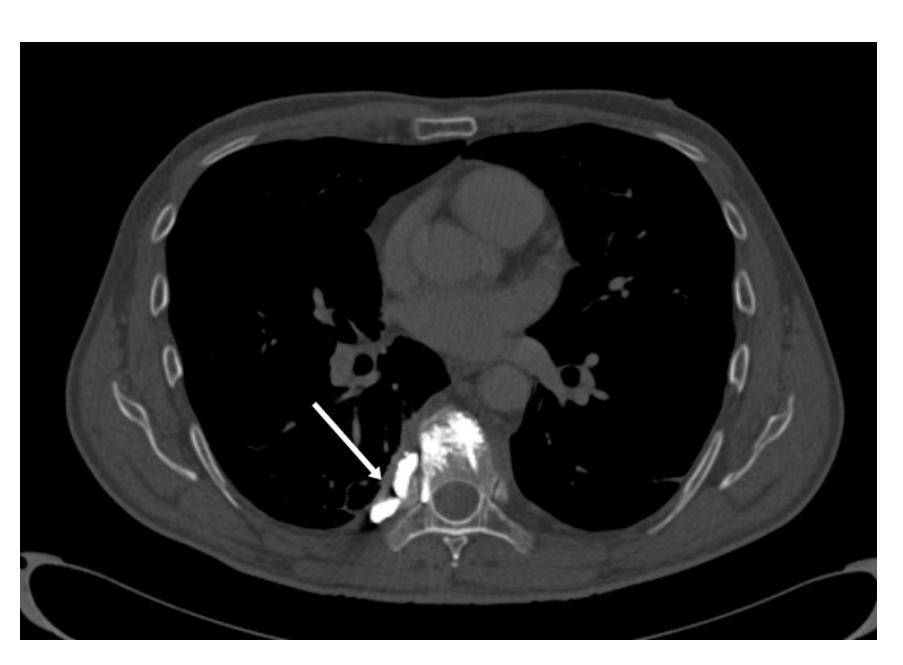
Figure 3. Cement leakage into the right subpleural space following vertebroplasty of Th8 vertebra (arrow).

Leakage was more frequently observed within the perivertebral venous plexus in comparison to the nearby intervertebral discs or the surrounding soft tissues (see Figure 3). The venous network traversing the vertebral column consists of three primary interconnected systems: the internal venous plexus, the external venous plexus, and the basivertebral system. Originating within the anterior one-third of the vertebral body, the basivertebral veins converge towards the posterior region, where they drain into the anterior part of the internal venous plexus. In the anterior area, these basivertebral veins merge with the external plexus. Positioned on the dorsal surface of the vertebral body, the exit point of the basivertebral vein lies centrally between the pedicles. The anterior component of the internal venous plexus empties into the segmental veins, which exit the spinal canal through the foramen located between the nerve root and the medial aspect of the pedicles. This implies a direct venous link connecting the bone marrow with the foraminal space [20].

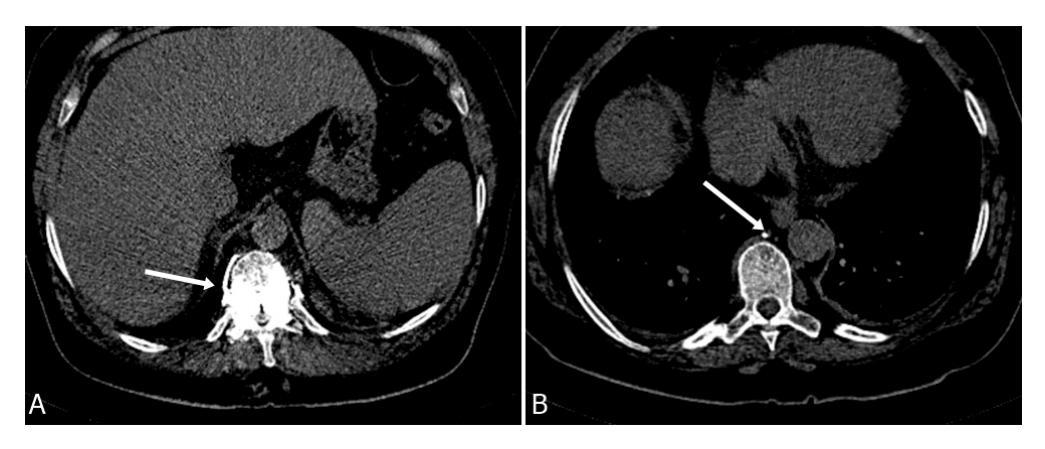
Figure 4. Axial CT scan of a 64-year-old woman following vertebroplasty of Th12 vertebrae with an arrow pointing to a cement leak into the paravertebral venous system (**A**). Cement can be seen in the azygos vein (**B**). Patient remained asymptomatic and late cement migration during follow-up did not occur.

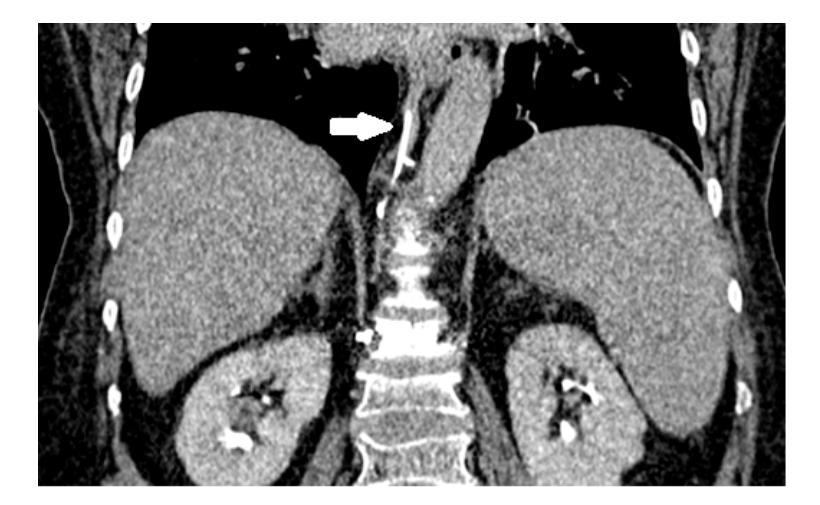
Figure 5. Sagittal CT scan of the same patient. Cement can be seen in the azygos vein (arrow).

The only sign that can predict the development of a pulmonary cement embolism is fluoroscopic evidence of cement leakage to the azygos vein or vena cava during vertebroplasty (Figures 4 and 5). Bone cement extravasates toward the vertebral venous plexus which is connected to the azygos system by which it reaches the inferior vena cava, the right cardiac chamber, and finally the pulmonary arterial system which may lead to a potentially fatal pulmonary embolism [23,24].

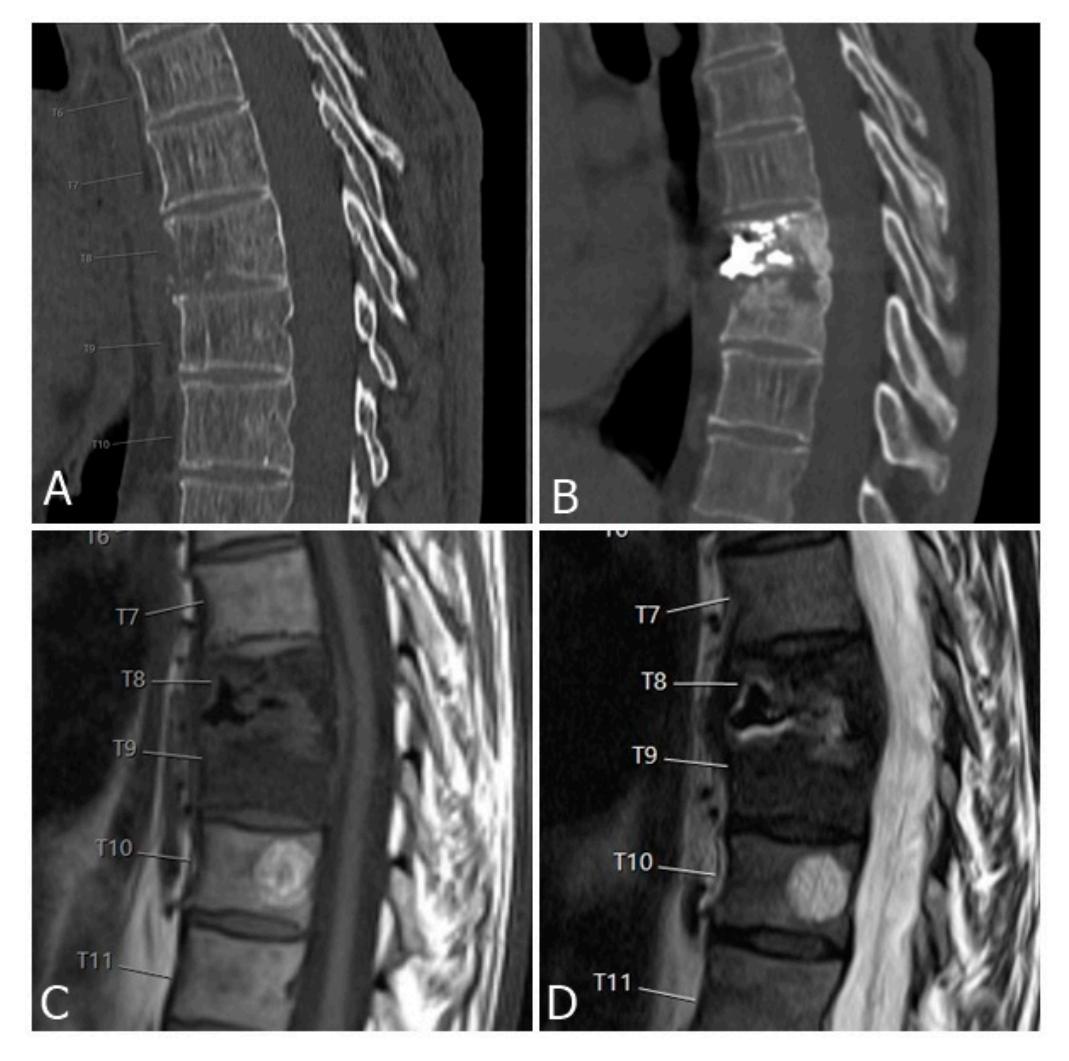
Figure 6. (**A**) CT scan of the thoracic spine of a 59-year-old man shows infiltration of the Th8 vertebral body by a neoplastic process. Biopsy and vertebroplasty were performed. Three months after procedure, the patient was presenting with new severe back pain and high C-reactive protein tests. CT shows the loss of intervertebral disc space height and bony destruction of Th8 and Th9 vertebrae (**B**). Bony destruction and low signal in disc space and adjacent endplates can be seen on T1-weighted images (**C**), as well as high signal in disc space and adjacent endplates on T2-weighted images (**D**), consistent with fluid in disc space and bone marrow oedema, all suggesting advanced spondylodiscitis.
