Source / Izvornik: **Collegium Antropologicum, 2009, 33, 1423 - 6**

Bifocal Stress Fracture of Pubic Rami after Contralateral Total Hip Arthroplasty and Longstanding Ipsilateral Hip Fusion

In this case report we present a patient with bifocal pubic rami stress fractures after contralateral total hip arthroplasty for congenital hip dysplasia and longstanding ipsilateral hip fusion. Treatment protocol for patients with various degrees of hip arthritis on one side and contralateral longstanding hip fusion are proposed based on the literature and our and previously published cases.

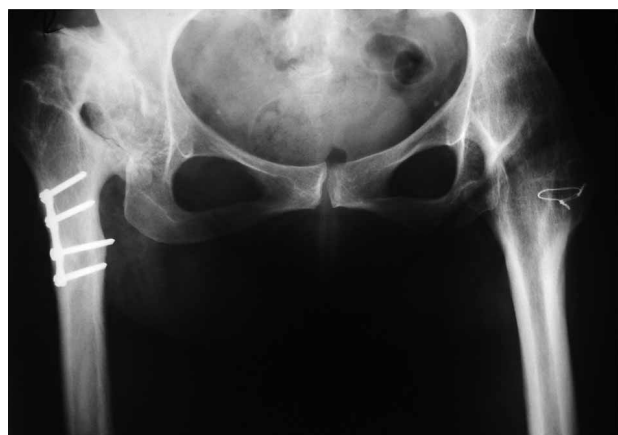
Fig. 1. Preoperative X-ray of both hips. Left hip: longstanding (45 years) hip fusion, right hip: high hip dislocation, plate and screws 47 years after intertrochanteric osteotomy.

due to congenital right hip dysplasia and longstanding left hip fusion (Figure 1). The patient had bilateral congenital hip dysplasia which was a reason to perform multiple hip operations in her childhood: intertrochanteric right hip osteotomy at the age of six and left hip fusion at the age of eight. Fusion of the left hip was performed in 10° abduction, 10° flexion and in neutral rotation, but the left leg was 3 cm longer than the right as a result of previous operations and high dislocation of the right hip (Crowe IV)¹⁴.

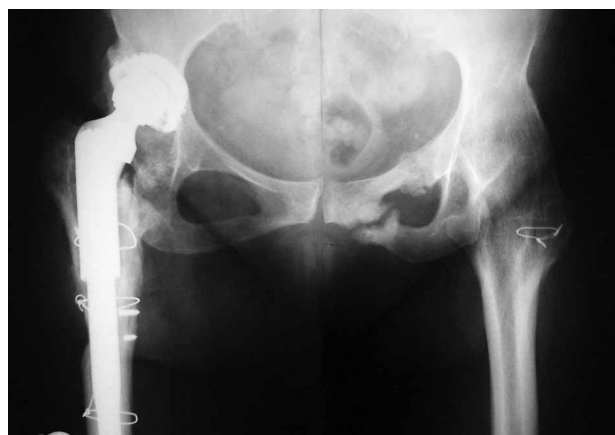
Fig. 2. Fully developed stress fracture of superior and inferior left pubic rami 11 months after right hip arthroplasty. Right hip: arthroplasty was performed with long stem to bridge the defect after plate and screw removal.

Approximately seven months after the right hip surgery (3 months of full weight bearing) the patient started to feel left groin pain during walking and standing. There was no history of trauma but she had »positive standing sign«¹⁷ (frank pain or an inability to stand unsupported on the affected leg) that is highly suggestive of pubic rami stress fracture. Control x-rays, one year and eight months after surgery, indicated left superior and inferior pubic rami stress fractures (Figure 2). There was

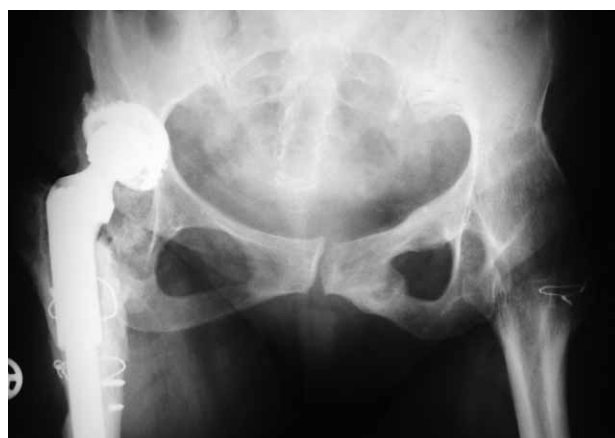
Fig. 3. Two years after right hip arthroplasty healing of stress fracture occurred.

Karol et al.²⁴ in their study described gait and function after intra-articular arthrodesis of the hip. Their patients had reduced cadence and step lengths, and the motion of pelvic and lumbar spine was excessive. They stated that the normal pelvis tilts posteriorly at the same time as the hip is in maximal flexion, and it tilts anteriorly during single limb stance in sagittal plane. In the coronal plane the pelvis drops slightly during the swing phase while in the transverse plane the pelvis rotates slightly internally as the swinging limb advanced and rotates externally in the stance phase. In the case of hip arthrodesis, pelvic motion in sagittal plane is decreased and pelvic rotation in the transverse plane increased during walking. Rotation in the lumbar spine was also enlarged¹². Walking pattern of our patient changed postoperatively. This was subjectively observed by the patient herself and the authors. Postoperatively, increased and pain free range of motion of the right hip (VAS 3) probably enabled longer step lengths which caused greater rotation of the pelvis, especially in the transverse plane. Since the lumbar spine, because of advanced degenerative lumbar changes, could not facilitate the rotation of the pelvis²⁵, pelvic girdle adjusted by creating additional »false« joint (where the bone was the weakest). This enabled longer step lengths and increased the right hip range of motion but produced a pain in the left groin area. This is only a speculation based on the previously published papers but probably all above mentioned factors contributed to some extent in developing stress fracture of the pubic bone by changed pelvic biomechanics^{6,18,24,26,27}. Development of the stress fracture could have been prevented if the patient was operated simultaneously on both hips or if the left hip was operated shortly after the right one. In this way all negative biomechanical causes would have been eliminated. All our patients scheduled for conversion of the hip fusion to the hip arthroplasty undergo prolonged preoperative rehabilitation with special emphasis on isometric exercises for fused hip abductors and rotators. However, although here reported patient underwent preoperative strengthening, we have not performed simultaneous bilateral arthroplasty because even one side arthroplasty would have imposed great stress to the patient and it was believed it will lead to a very long and slow postoperative rehabilitation (especially 45 years of non utilizing left hip abductors). Left hip conversion from fusion to arthroplasty within 3 months after the right hip arthroplasty would probably be a better solution because the patient would sufficiently recover from the first surgery and stress fracture would not yet develop. Stress fractures have a good outcome with conservative management and usually heal within a few weeks^{1,4,11,13}. In case of our patient control x-ray showed complete healing of pubic bone after two years.
