# Complications of Percutaneous Vertebroplasty: A Pictorial Review

**Keywords:** vertebroplasty; complication; cement leakage; spondylodiscitis

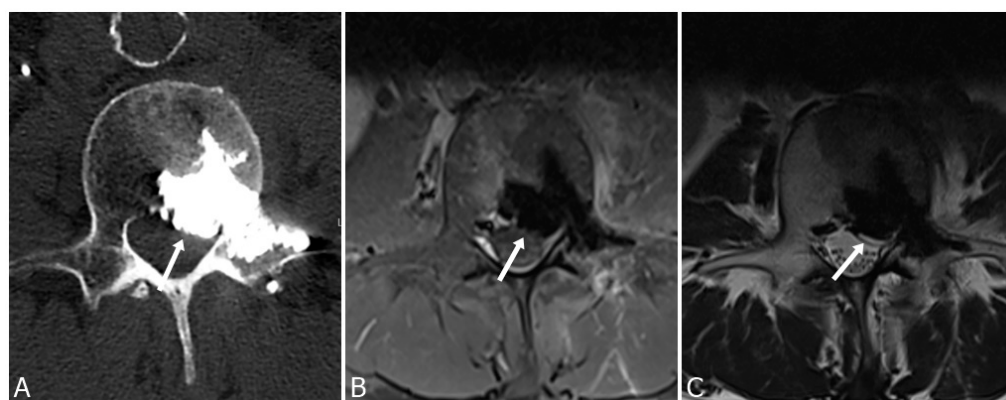
**Figure 1.** Cement leakage into epidural space with compression of the dural sac (arrows) seen on axial CT image (A), T1-weighted (B), and T2-weighted (C) MRI images, following vertebroplasty of L2 vertebrae in a 67-year-old man.

Cement leakage into the epidural space can be classified into three distinct categories: type B entails leakage via the basivertebral vein, type S involves the segmental vein route, and type C arises through a cortical breach. Leaks of type B originate from the vascular foramen and advance into the spinal canal, disseminating along the epidural venous plexus.

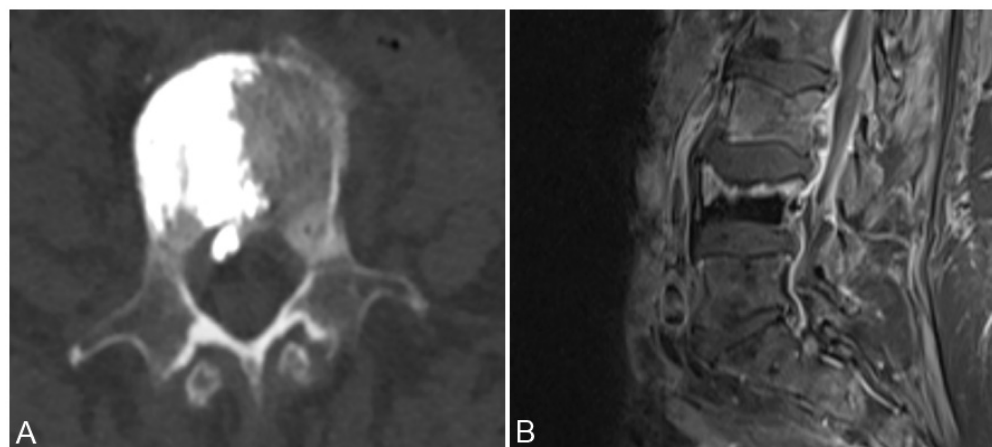
**Figure 2.** Axial CT image (A) and T2 weighted sagittal MRI image (B) show discrete intraspinal bone cement leakage.

Type S leaks usually follow a horizontal trajectory, tracing alongside the segmental veins. On the other hand, type C leakage emerges from a cortical disruption encircling a vertebral body, potentially extending into the spinal canal (refer to Figure 2) [19].

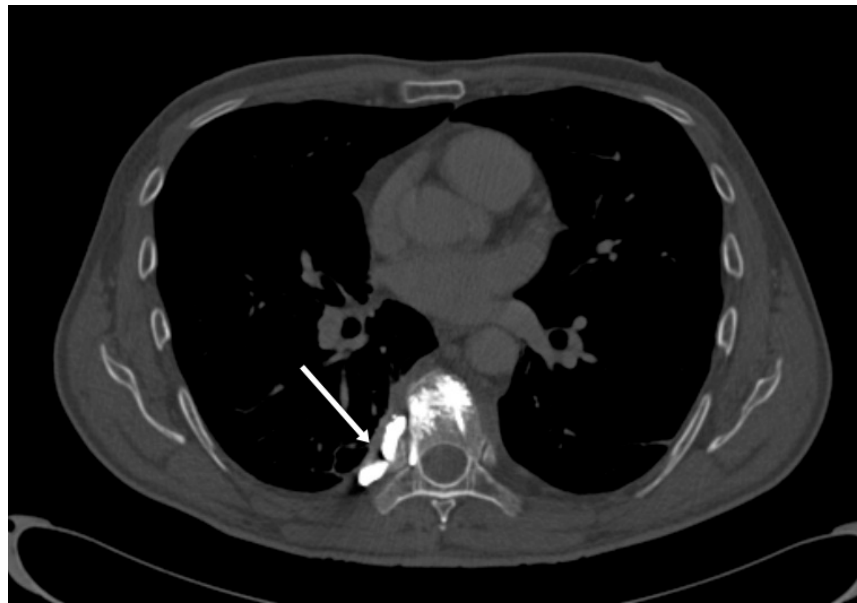
**Figure 3.** Cement leakage into the right subpleural space following vertebroplasty of Th8 vertebra (arrow).

Leakage was more frequently observed within the perivertebral venous plexus in comparison to the nearby intervertebral discs or the surrounding soft tissues (see Figure 3). The venous network traversing the vertebral column consists of three primary interconnected systems: the internal venous plexus, the external venous plexus, and the basivertebral system. Originating within the anterior one-third of the vertebral body, the basivertebral veins converge towards the posterior region, where they drain into the anterior part of the internal venous plexus. In the anterior area, these basivertebral veins merge with the external plexus. Positioned on the dorsal surface of the vertebral body, the exit point of the basivertebral vein lies centrally between the pedicles. The anterior component of the internal venous plexus empties into the segmental veins, which exit the spinal canal through the foramen located between the nerve root and the medial aspect of the pedicles. This implies a direct venous link connecting the bone marrow with the foraminal space [20].

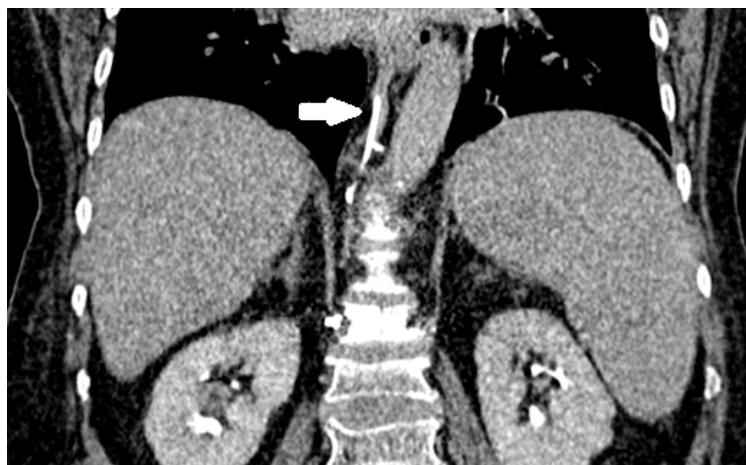
**Figure 5.** Sagittal CT scan of the same patient. Cement can be seen in the azygos vein (arrow).

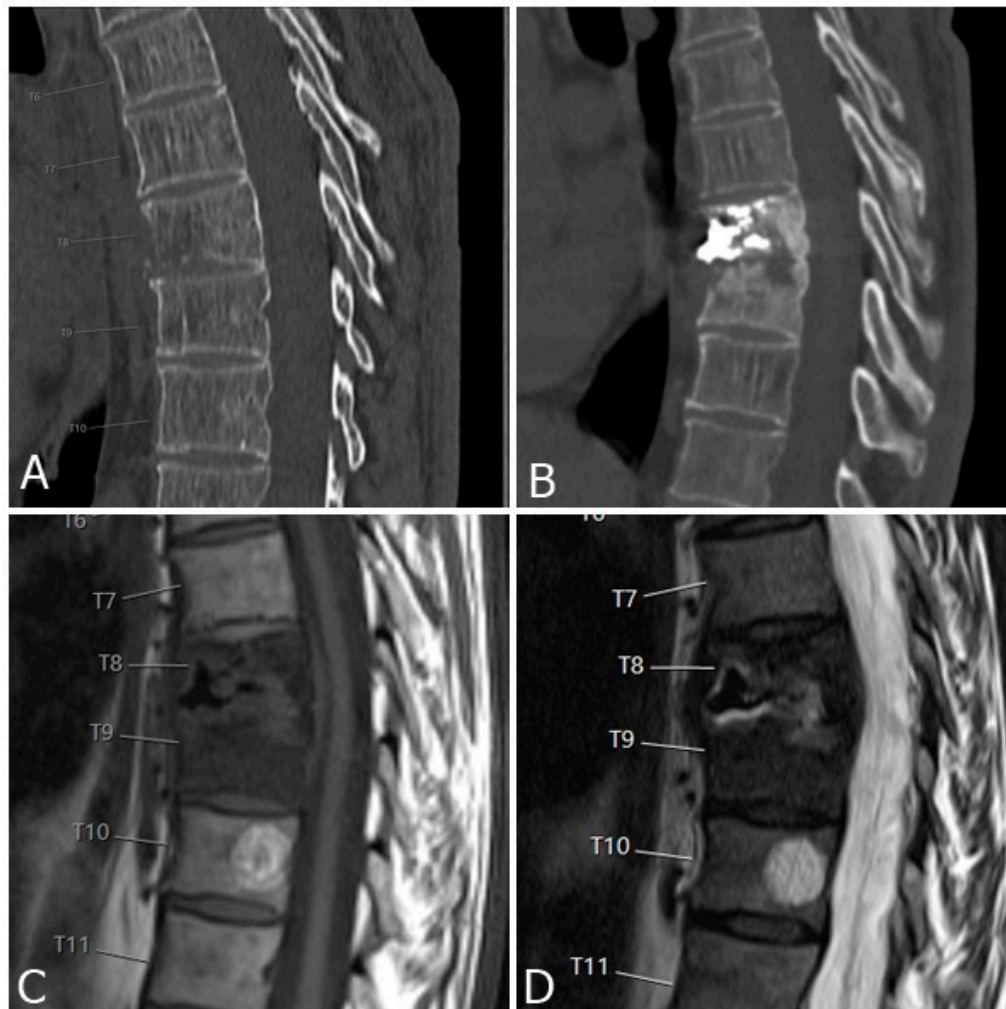
**Figure 6.** (A) CT scan of the thoracic spine of a 59-year-old man shows infiltration of the Th8 vertebral body by a neoplastic process. Biopsy and vertebroplasty were performed. Three months after procedure, the patient was presenting with new severe back pain and high C-reactive protein tests. CT shows the loss of intervertebral disc space height and bony destruction of Th8 and Th9 vertebrae (B). Bony destruction and low signal in disc space and adjacent endplates can be seen on T1-weighted images (C), as well as high signal in disc space and adjacent endplates on T2-weighted images (D), consistent with fluid in disc space and bone marrow oedema, all suggesting advanced spondylodiscitis.
