A simple new technique for the removal of fractured femoral stems: a case report

We present a case of fracture of a cementless long femoral stem, which is mainly used in tumor and revision surgery, and a useful technique to remove it from the intramedullary space of the femur.

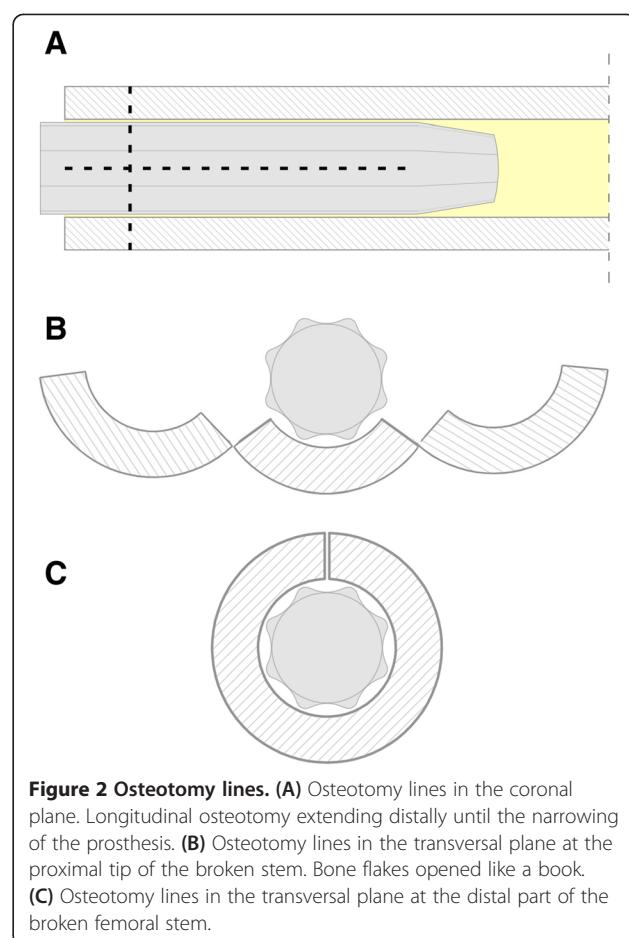
Figure 2 Osteotomy lines. (A) Osteotomy lines in the coronal plane. Longitudinal osteotomy extending distally until the narrowing of the prosthesis. (B) Osteotomy lines in the transversal plane at the proximal tip of the broken stem. Bone flakes opened like a book. (C) Osteotomy lines in the transversal plane at the distal part of the broken femoral stem.

Our patient was given spinal anesthesia, in the lateral decubitus position. We used the direct lateral approach that was extended distally. The fracture was 7cm distally from the tip of the greater trochanter, just at the junction of the proximal and distal modular parts and at the level of the remaining bone after the primary resection (Figure 1). The proximal part of the femoral stem was extracted easily and without complications. We continued with the disengagement of the proximal portion of the distal part of the femoral stem from the surrounding bone. We needed at least 2cm to have enough space for two locking pliers. This was achieved with a longitudinal osteotomy through the anterior cortex extending distally for 10cm (Figure 2A). The transversal osteotomy was 2cm below the tip of the femoral stump to allow enough space for two locking pliers. The transversal osteotomy was about 60 to 70 percent of the total bone circumference as shown (Figure 2B). A lamina spreader was then inserted in the osteotomy line proximally and two bone

flakes were opened like a book in order to provide space for the tip of the locking pliers (Figure 2B). The proximal tip of the broken stem was compressed as much as possible with two locking pliers. A lamina spreader was then inserted in the remaining distal longitudinal osteotomy and carefully opened for 1 to 2mm to allow the bone to separate from the stem, avoiding fracture of the femur (Figure 2C). Simultaneously, a hammer was used on the locking pliers and with several strong strokes the broken stem was removed from the bone easily (Figure 3). Next, a cerclage wire was inserted below the horizontal cut to prevent a possible uncontrolled fracture of the femoral bone during broaching. A second cerclage wire was inserted on the proximal 2cm of the femoral bone, which adapted perfectly. The femoral canal was reconstructed perfectly with minimal damage to the periosteum. The new revision prosthesis was then inserted in the standard manner (Figure 4).

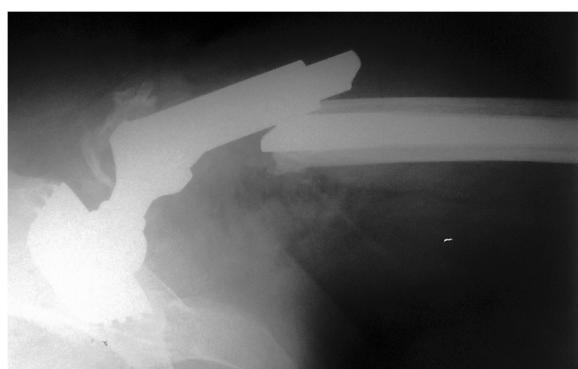
Figure 1 Plain radiograph of the fractured prosthesis.

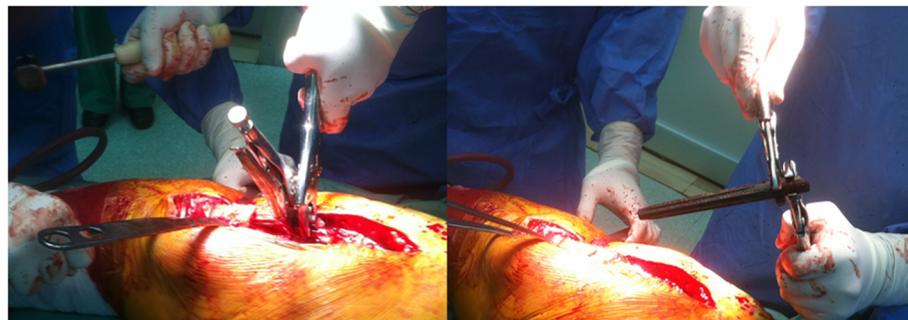
Figure 3 Intraoperative photographs.

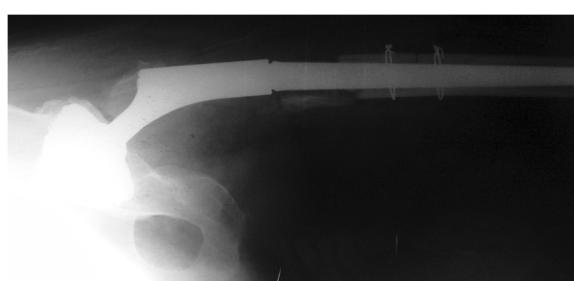
Figure 4 Postoperative plain radiograph. Note the excellent adaptation of the osteotomy lines.

excellent adaptation of the osteotomy line. Damage to the periosteum is only done during osteotomy through the anterior cortex and is minimized, which also promotes bone healing. Good fixation of the new revision prostheses can be made due to bone stock conservation and the excellent adaptation of the osteotomy line. This enables early mobilization and rehabilitation of the patient, minimizing the postoperative complications.
