Bifocal Stress Fracture of Pubic Rami after Contralateral Total Hip Arthroplasty and Longstanding Ipsilateral Hip Fusion

ABSTRACT

In this case report we present a patient with bifocal pubic rami stress fractures after contralateral total hip arthroplasty for congenital hip dysplasia and longstanding ipsilateral hip fusion. Treatment protocol for patients with various degrees of hip arthritis on one side and contralateral longstanding hip fusion are proposed based on the literature and our and previously published cases.

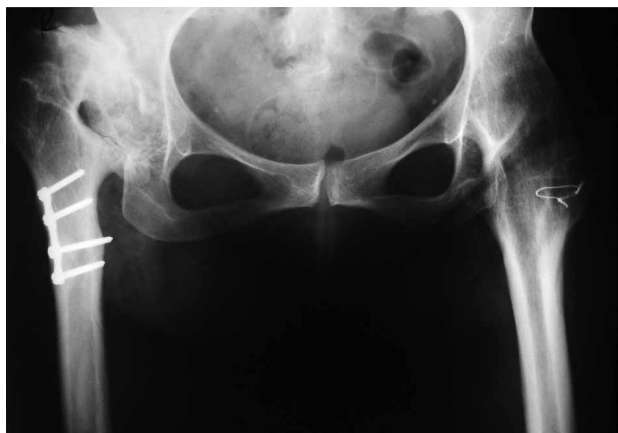
Fig. 1. Preoperative X-ray of both hips. Left hip: longstanding (45 years) hip fusion, right hip: high hip dislocation, plate and screws 47 years after intertrochanteric osteotomy.

due to congenital right hip dysplasia and longstanding left hip fusion (Figure 1). The patient had bilateral congenital hip dysplasia which was a reason to perform multiple hip operations in her childhood: intertrochanteric right hip osteotomy at the age of six and left hip fusion at the age of eight. Fusion of the left hip was performed in 10° abduction, 10° flexion and in neutral rotation, but the left leg was 3 cm longer than the right as a result of previous operations and high dislocation of the right hip (Crowe IV)¹⁴.

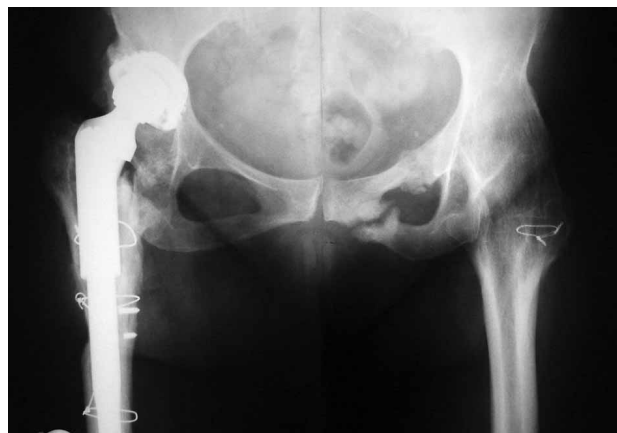
Fig. 2. Fully developed stress fracture of superior and inferior left pubic rami 11 months after right hip arthroplasty. Right hip: arthroplasty was performed with long stem to bridge the defect after plate and screw removal.

Approximately seven months after the right hip surgery (3 months of full weight bearing) the patient started to feel left groin pain during walking and standing. There was no history of trauma but she had »positive standing sign«¹⁷ (frank pain or an inability to stand unsupported on the affected leg) that is highly suggestive of pubic rami stress fracture. Control x-rays, one year and eight months after surgery, indicated left superior and inferior pubic rami stress fractures (Figure 2). There was
